Manhole Inspection Summary

Manhole # S13EE2039MH

Insp Date: **7/12/06 8:39 AM**

Location Address: **2114 WESTERN RUN DR** Cross Street: **EASTCLIFF DR**

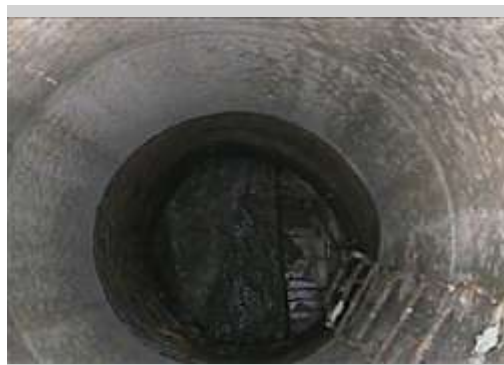
Top View

Barrel infiltration. Corroded steps.
Evidence of surcharge - Bench debris.

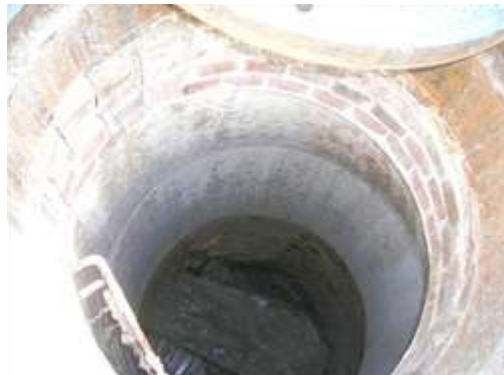
Defect

Frame leaks. Adjustment and Corbel
infiltration - other side.

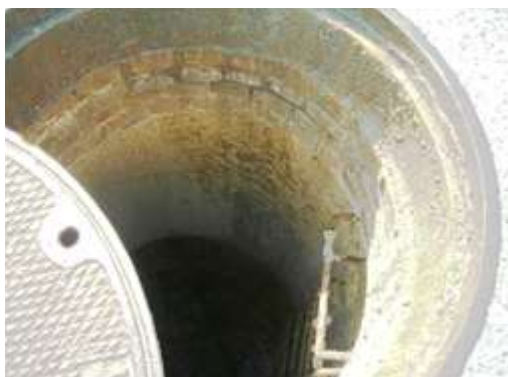
Defect

Frame leaks. Adjustment and Corbel
infiltration

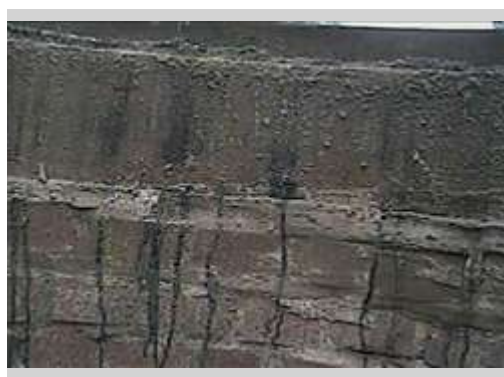
Defect

Frame leaks. Adjustment infiltration.

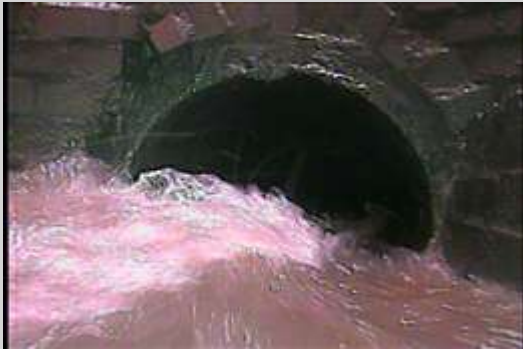
21 in. Circular Gravity Sewer Pipe Out @ 12 O'Clock

Infiltration: **None** Pipe Seal Cond: **Cracked**
